INSTALLATION INSTRUCTIONS FOR PART 99-5809

1998-2002 Lincoln Continental

99-5809

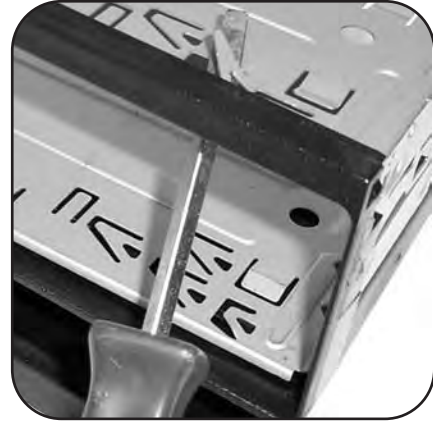
DIN HEAD UNIT PROVISION

- 1** Slide the DIN cage into the Radio Housing and secure by bending the metal locking tabs down.
- 2** Slide the after-market head unit into the cage and secure.
- 3** Snap the Trim plate into the Radio Housing.
