INSTALLATION INSTRUCTIONS

204016/204016-2

3" SIDEBAR WITH BENT END

04-10 CHEVY COLORADO/ GMC CANYON CREW CAB

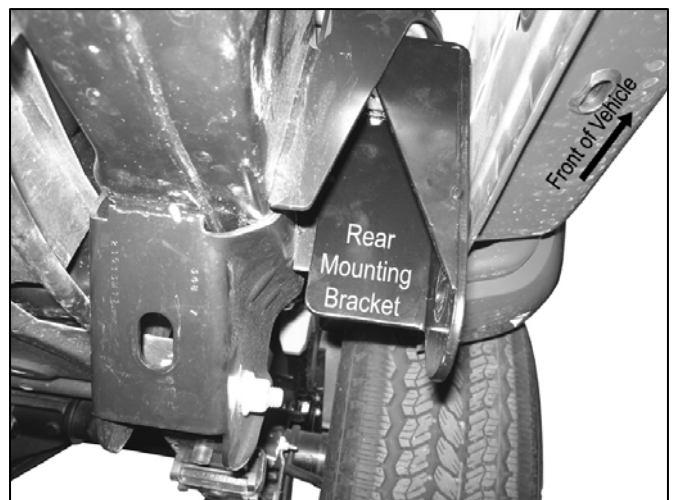
Driver Side Installation Pictured

- Locate the driver side front Mounting Bracket and bolt it to the vehicle using the factory body mount bolt, **NOTE:** Brackets mount over bushings.
- Locate the driver side rear Mounting Bracket and bolt it to the vehicle using the factory body mount bolts. **NOTE:** Brackets mount over bushings.

- Insert one of the 12mm Nut Plates through the bottom of the front face of the leaf spring mounting bracket and align it to the factory oval hole.
- With the 90-degree bend towards the side of the vehicle and facing up, partially attach the driver side Support Bracket to the already inserted Nut Plate using the included (1) 12mm x 30mm Hex Head Bolt, (1) 12mm Lock Washer and (1) 12mm Flat Washer **NOTE:** The 90-degree bent end of the Support Bracket should line up with the hole in the rear Mounting Bracket. Snug but do not tighten hardware at this time.

- Carefully position the driver Sidebar up to the Mounting Brackets. Line up the mounting hole in the Front Support Bracket with the hole in the Front Mounting Bracket, **(Figure 9)**. Use the included (2) 12mm x 50 Hex Head Bolts, (2) 12mm Lock Washers, and (2) 12mm Flat Washers to attach the Sidebar to the Mounting Brackets
