99-7007 INSTALLATION INSTRUCTIONS

MITSUBISHI Eclipse 2000-05

MITSUBISHI Montero Sport 2000-04

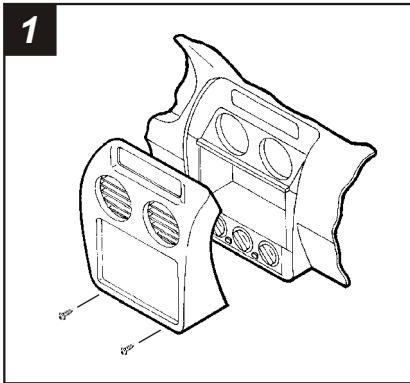
1
Disconnect the negative battery terminal to prevent an accidental short circuit. Remove (2) Phillips screws under the climate controls. Unclip the radio/climate control trim bezel and remove the bezel. Remove (4) Phillips securing the factory head unit and disconnect the wiring.

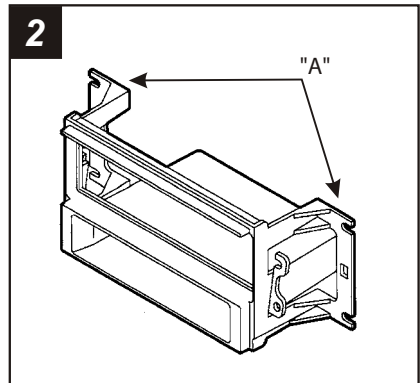
2
Locate tabs "A" on the Radio Housing. Skip to the Installation Instructions for ALL VEHICLES on Page #2.

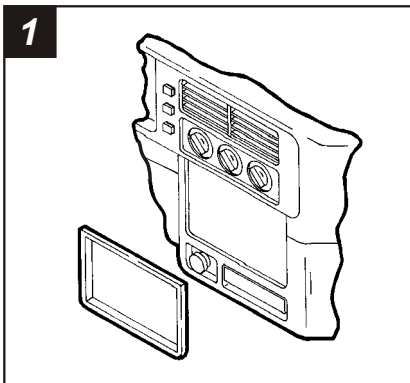
1
Disconnect the negative battery terminal to prevent an accidental short circuit. Unclip the radio/climate control trim bezel and remove the bezel. Remove (4) Phillips securing the factory head unit and disconnect the wiring.

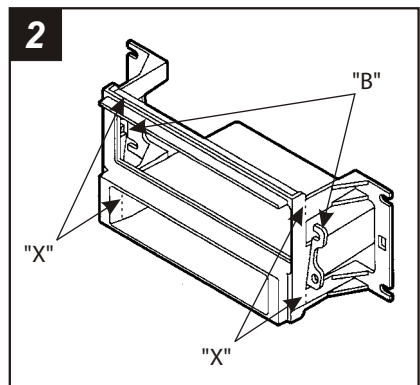
2
Locate tabs "B" on the Radio Housing. Cut and remove the mounting legs containing tabs "A" by cutting along dotted lines "X". Skip to the Installation Instructions for ALL VEHICLES on Page #2.

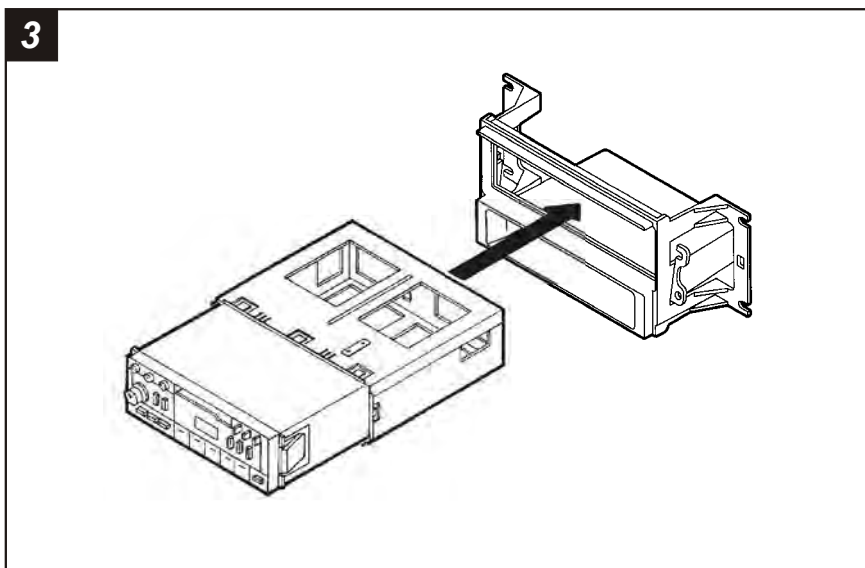
3

Slide the DIN cage into the Radio Housing and secure by bending the metal locking tabs down. Slide the aftermarket head unit into the cage until secure.

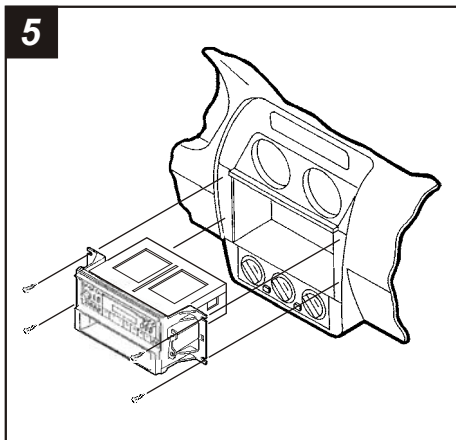
5

Re-connect the battery terminal and test the unit for proper operation. Mount the head unit/kit assembly to the sub-dash with (4) Phillips screws previously removed in step #1.
